Desilting of Lake Inkwil

. . . to be met for an extraordinary project

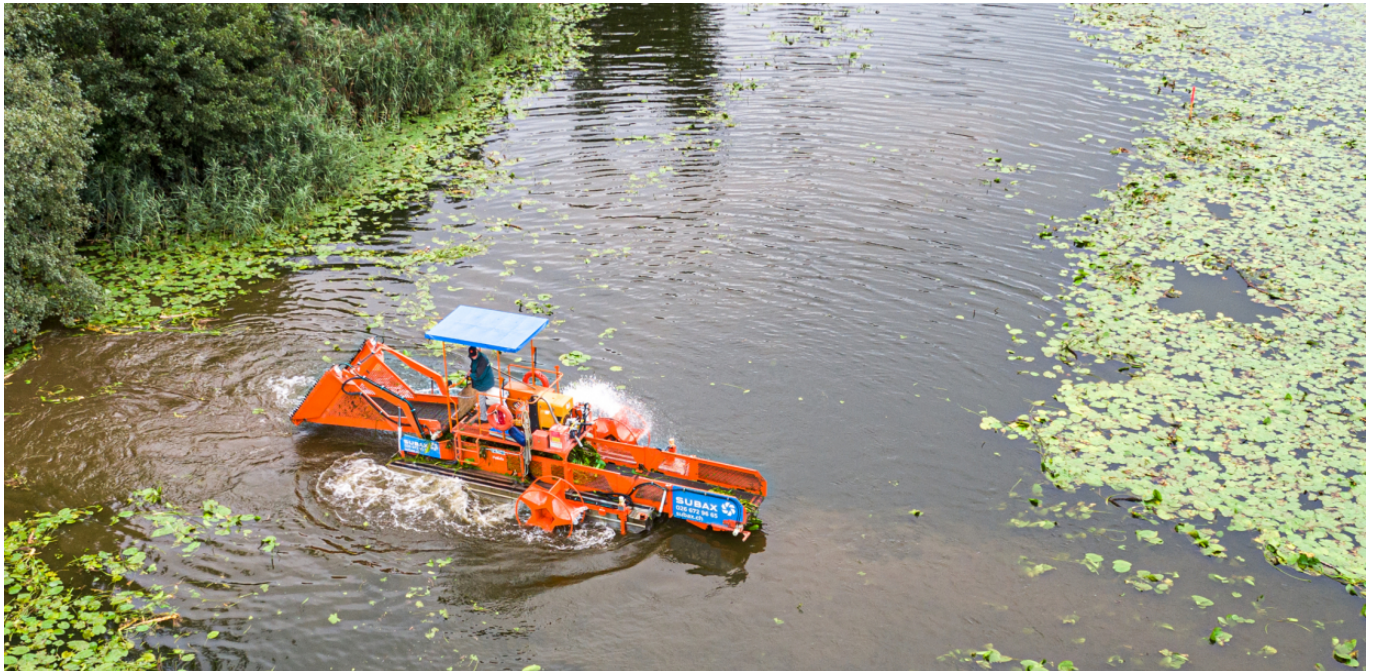
Suction dredger in operation

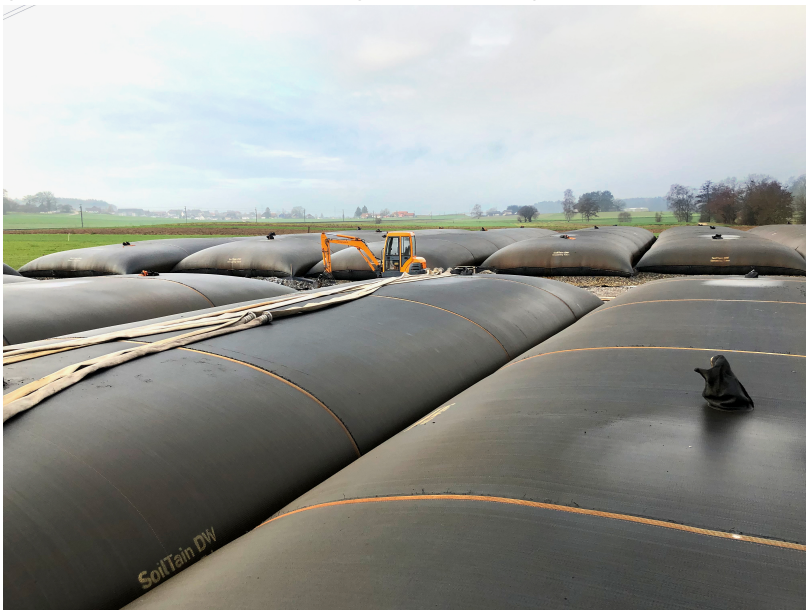
Filled geotubes at the drainage site

To prepare for the silt removal operation and ensure compliance with environmental specifications, EBP was charged with coordinating various measures. These included removing water lilies by means of a mowing boat, taking measurements of and sampling the lake bed, and deploying two teams of scuba divers specifically for examining sensitive, submarine archeological features and resettling mussels in the area. Upon completion of these protective measures, a dredge was then deployed to break apart the water lily rhizomes and vacuum the silt. The silt was subsequently pumped from the previously installed drainage site into large geotextile bags, also known as geotubes, for further drainage and filtering.
