Renovation of a heritage-protected building owned by the Swiss National Bank

The Swiss National Bank recently renovated a 130-year-old property located at 8, Fraumünsterstrasse in Zurich. With the aim of securing earthquake resistance and accommodating new building functions, EBP completed the planning for the modification of the load-bearing structures.

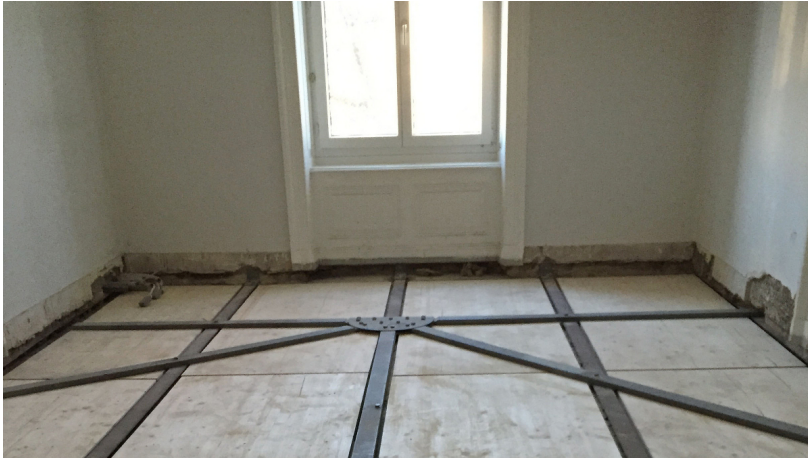
Ceiling structures (Picture Credits: EBP)

The execution of the construction measures in a heritage-protected building presented a special challenge, especially given the need to preserve the valuable stucco ceilings and coordinate the efforts of multiple contractors. For instance, we needed to carefully harmonize the arrangement of the earthquake-resistant, horizontal steel-truss structures with all cable ducts and floor structures.

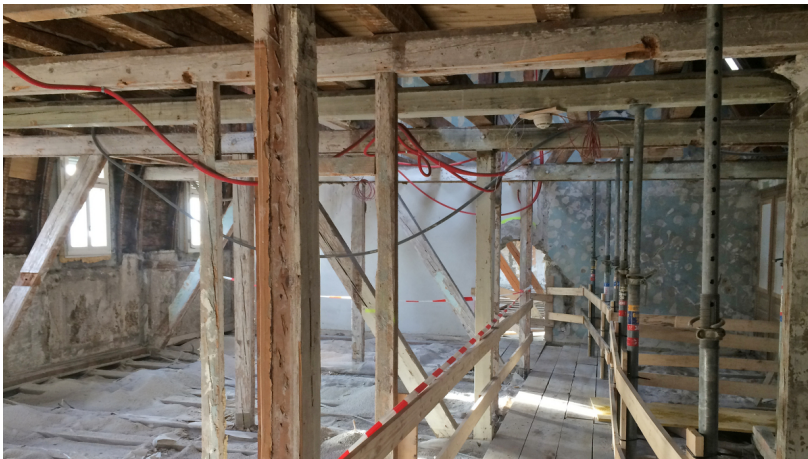
Exposed attic (Picture Credits: EBP)

- Earthquake-proofing (reinforcement of floors with horizontal steel trusses, installation of a vertical steel truss and reinforced concrete walls)
- foundation of quake-resistant walls with micropiles
- Installation of new utility elevator and pit below groundwater level
- Reinforcement of wood floor beams and steel-beam, tamped-concrete floor, partial replacement with new reinforced concrete slabs
- Installation of a new building-services unit in the attic with composite, steel-concrete slabs

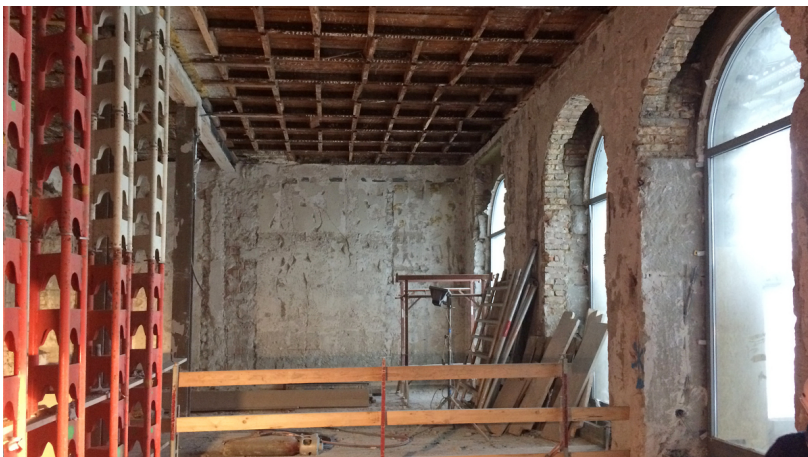
Wood-beam ceilings on first floor (Picture Credits: EBP)

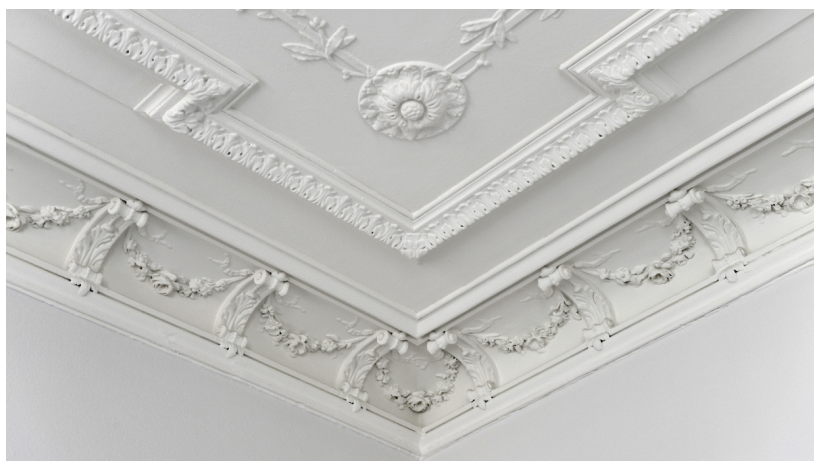
Preserving the delicate stucco work (Picture Credits: Marco Blessano)
